Workshop on “Design, Construction and Maintenance of Steel Bridges”

Forensic Investigation of Bowstring Girder during Construction

V N Heggade

19-20 October, 2024

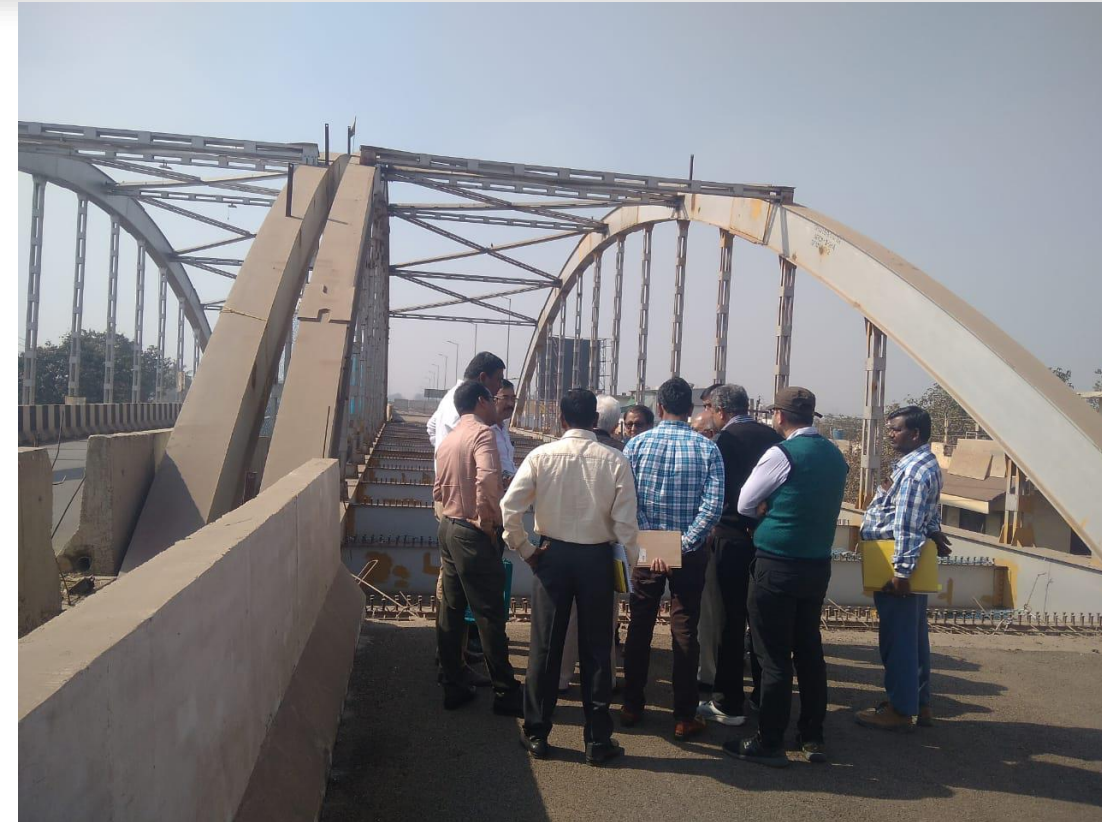
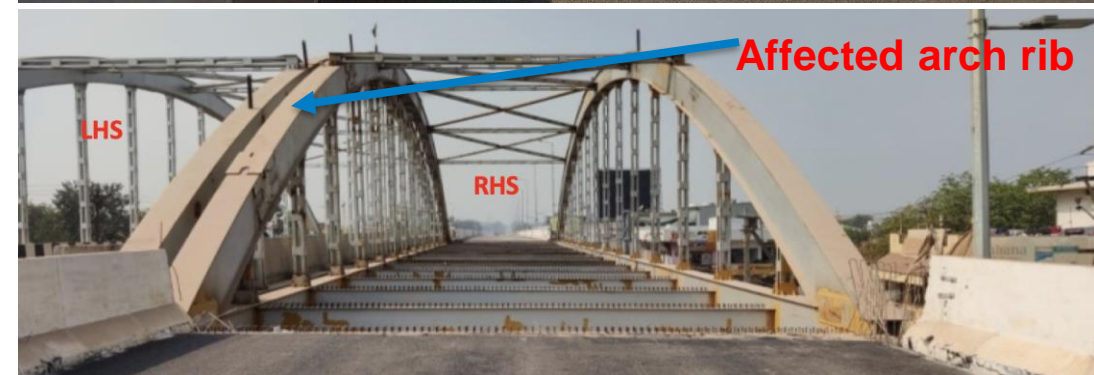
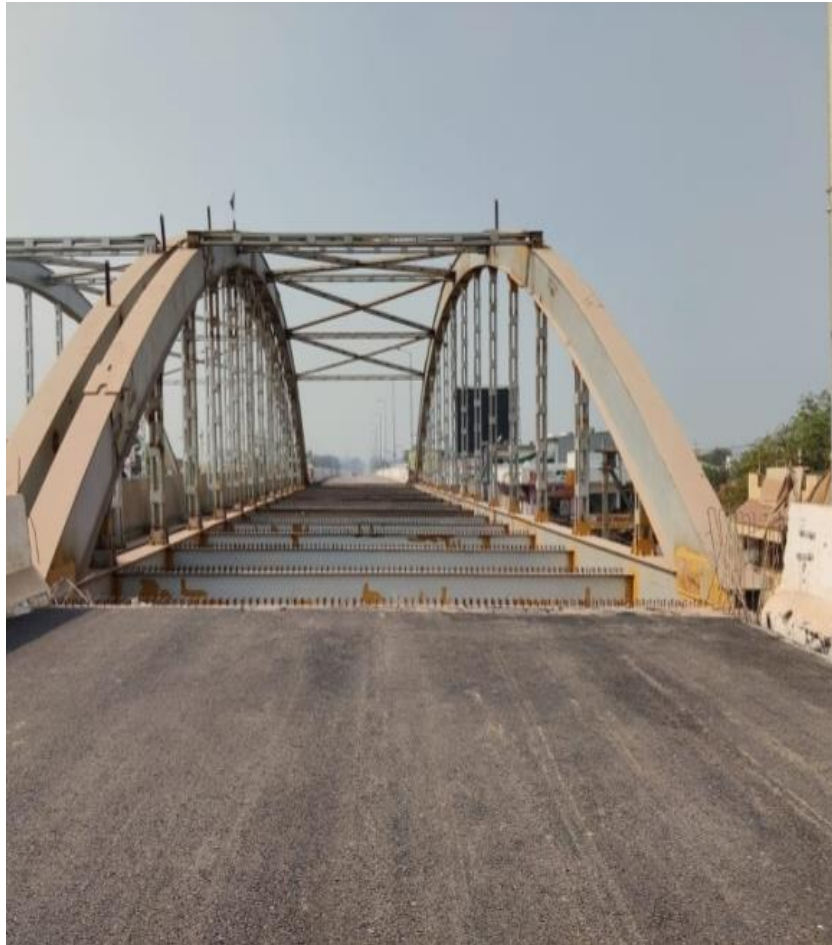
- During the erection, one of the arch ribs and bottom tie chord of RHS which is towards median side adjacent to already commissioned LHS arch bridge was found to be distorted beyond tolerance limits.
- On either side, the approaches were ready for commissioning. Only the deck slab was to be cast on floor beams.
- At the time of appointment of forensic expert, the distortion in the arch rib was corrected to certain extent but the acceptability of the same was in question.

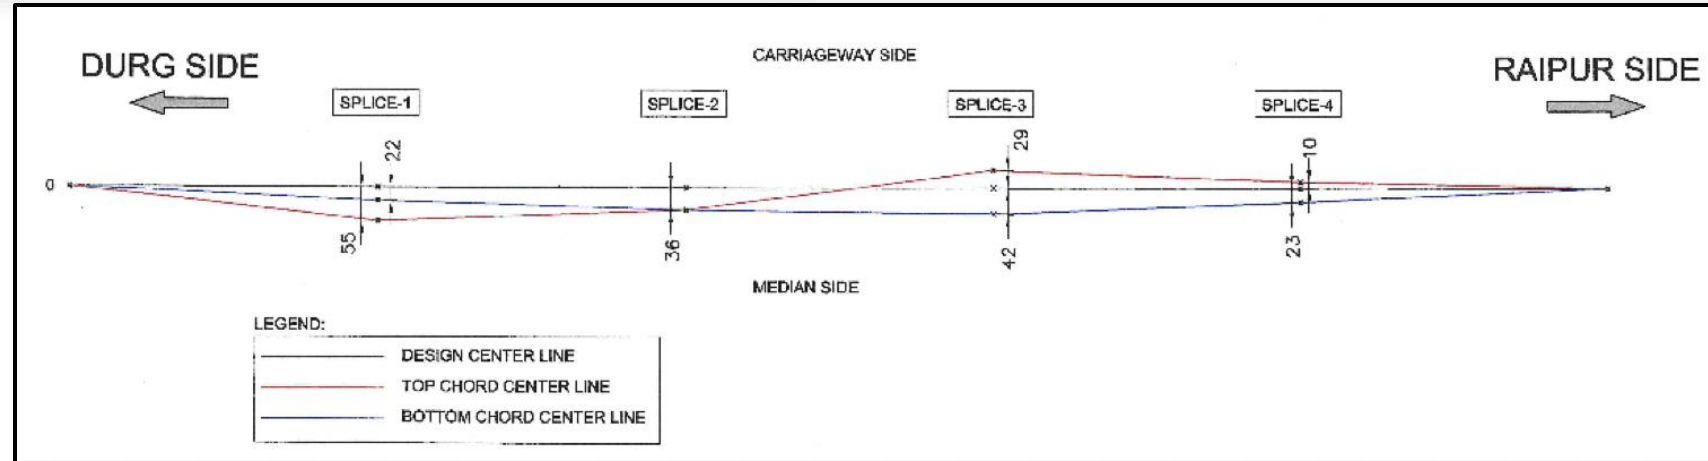
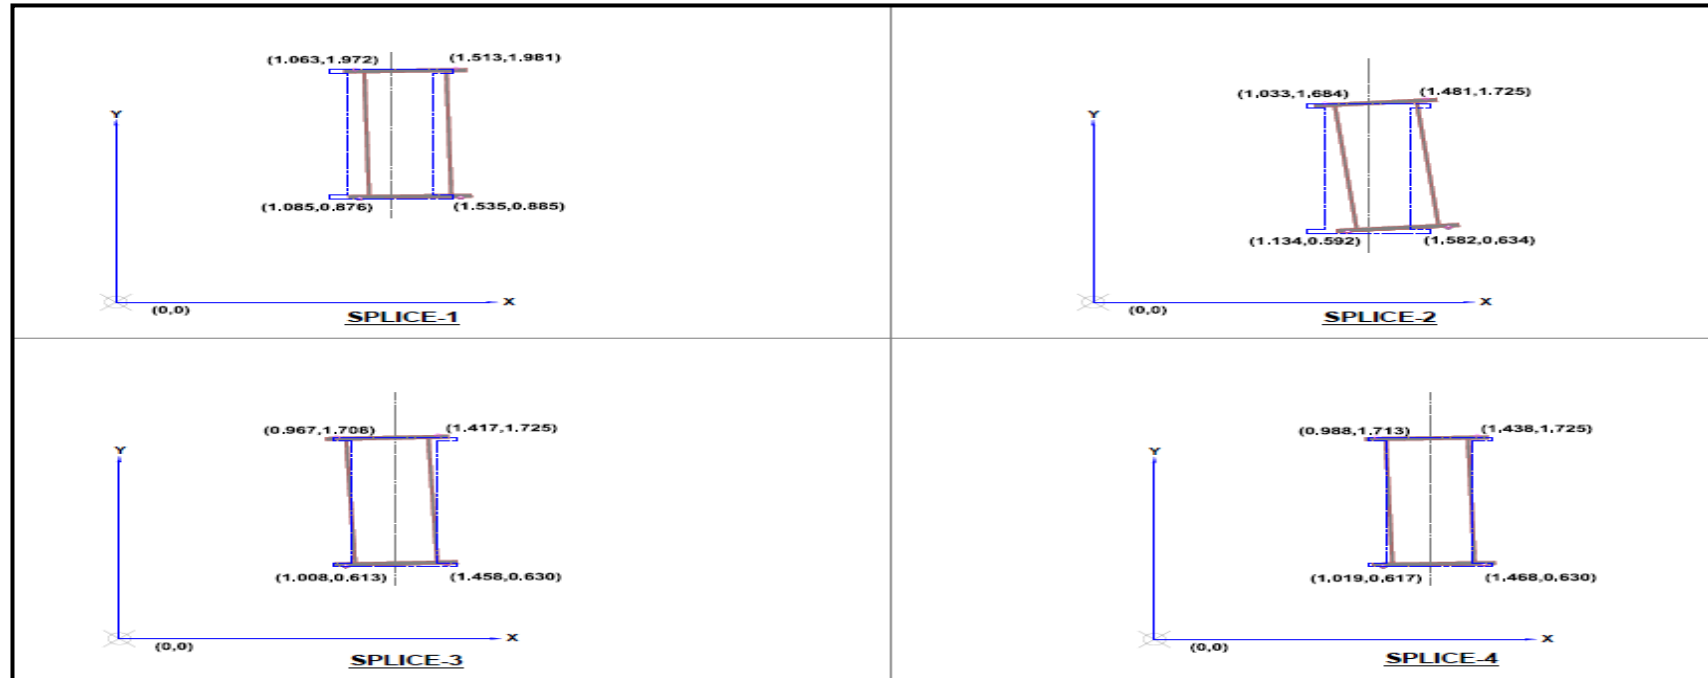
- Distortion in the alignment of one of the arch ribs and Bottom chord was detected during inspection.
- The distortion in the arch rib & the Tie chord were much beyond the permissible limits mentioned in IRC : Sp-104 and IRC : 24-2010.

- The segment TC3 was most distorted.
- All 5 segments of the arch rib TC-1 to TC-3 & TC-1X to TC-2X were replaced with newly fabricated segments.
- The shape (dumble) & location of splices were changed
- Distortion was brought under the permissible limits.

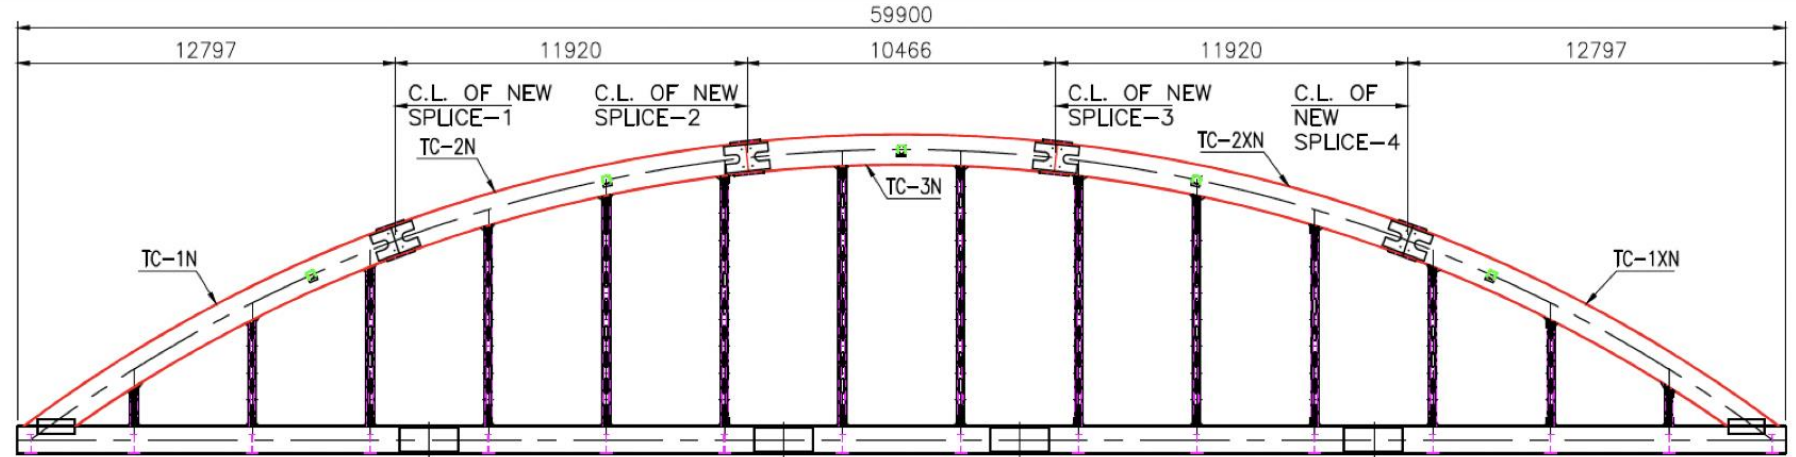
Replaced arch ribs & modified splice location & shape.

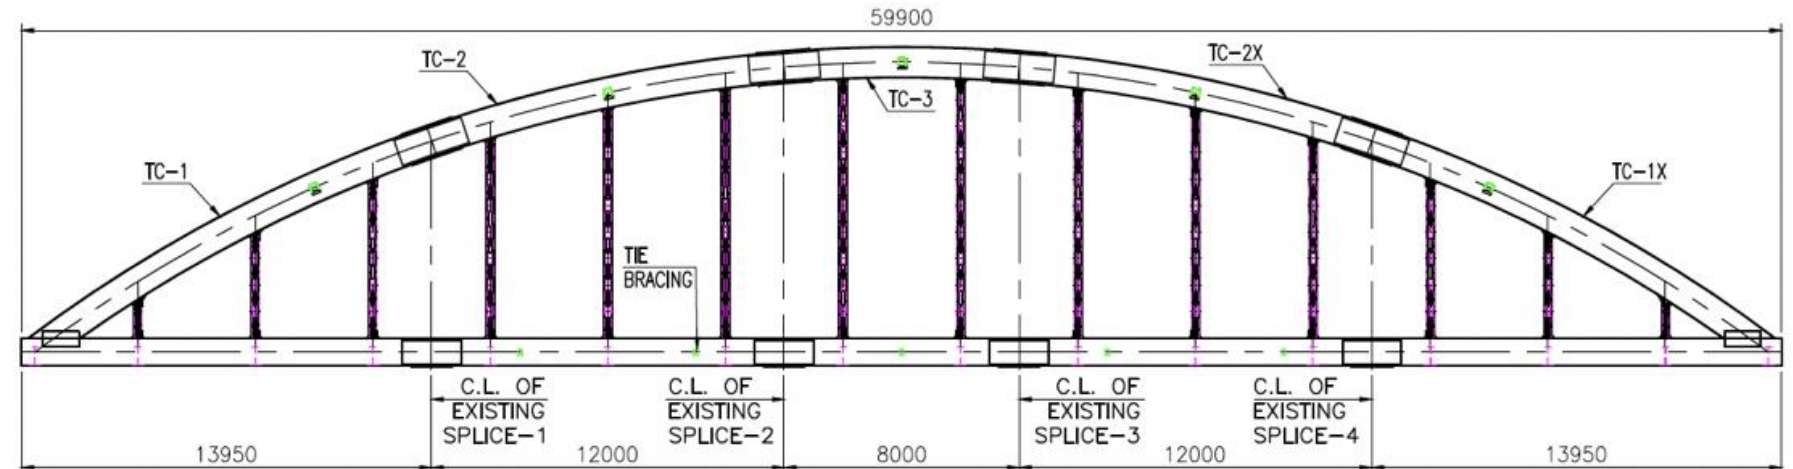
Original splicing in the arch rib
