ING - IABSE
WORKSHOP ON DESIGN, CONSTRUCTION, AND
MAINTENANCE OF STEEL BRIDGES
DEHRADUN 19-20 OCTOBER 2024

LECTURE ON “SUSTAINABLE USAGE OF STEEL IN BRIDGES”

AMITABHA GHOSHAL

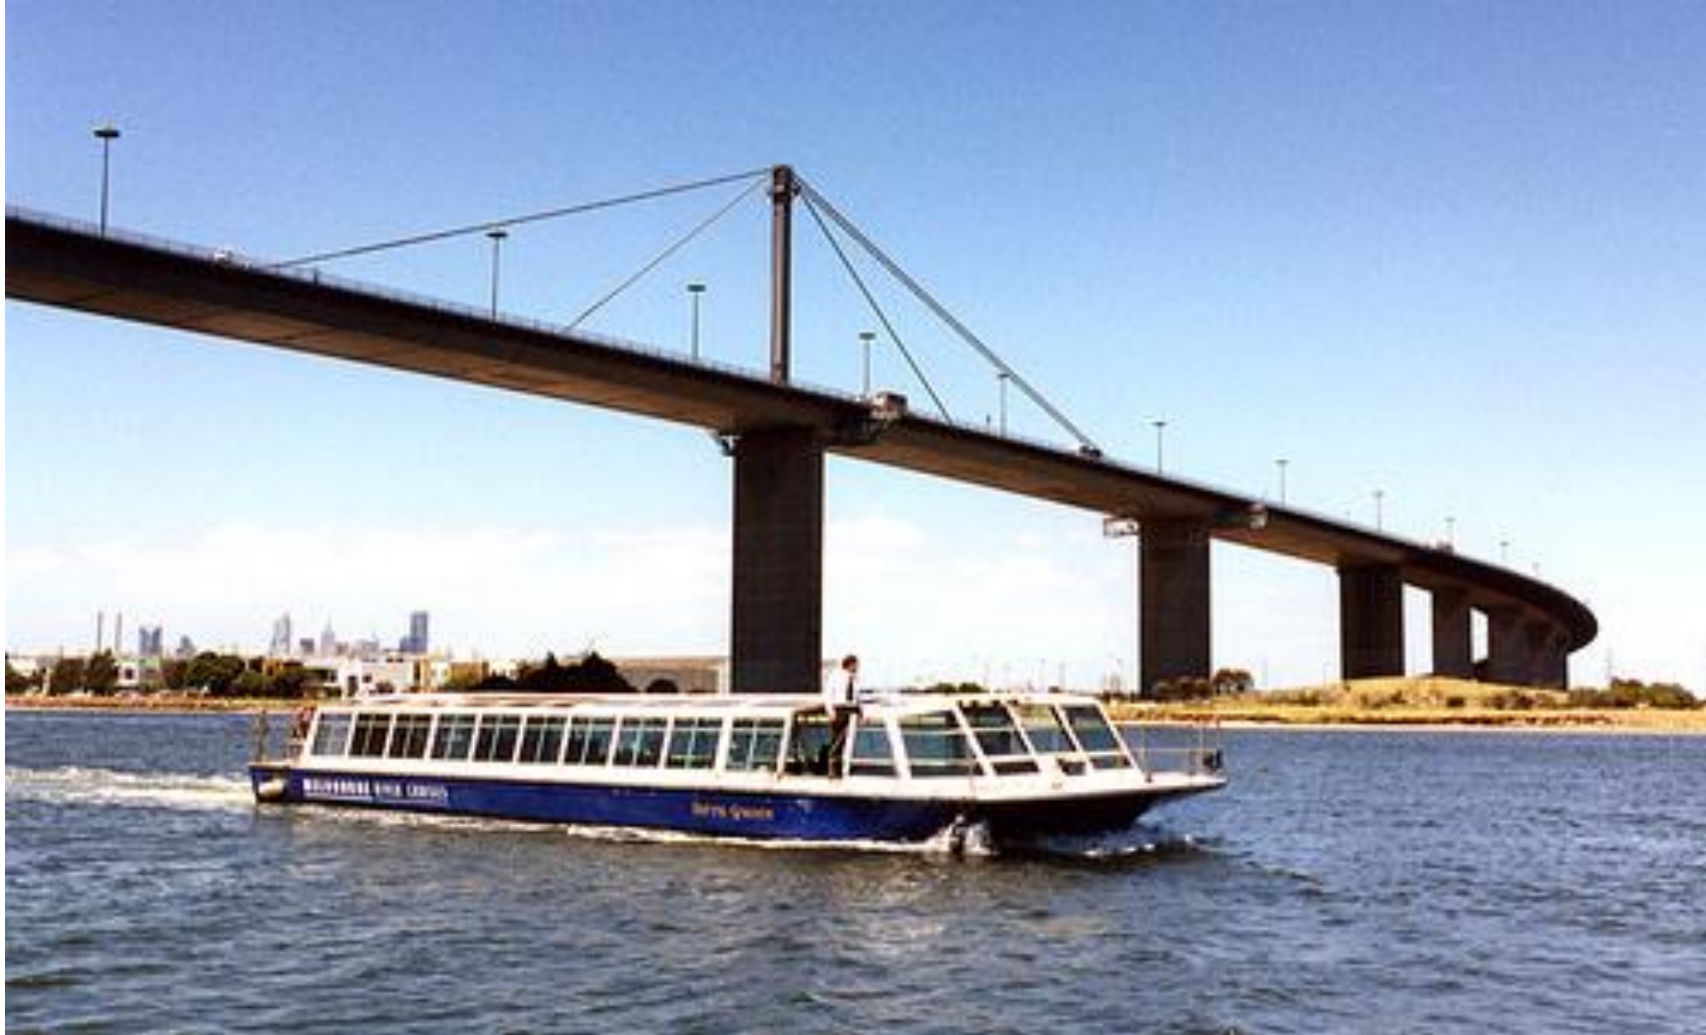
Westgate Bridge, Melbourne, Australia – Present picture

- This 2.6 km long bridge across Yarra river, with a cable-stayed span of 336 m, and side spans of 112m composite box girders, one of which collapsed during construction, resulting in a large number (35) deaths, and many serious injuries. It is remembered as the worst industrial accident in Australia.
- Crossing the river at a height of 58 m the multi-cellular box had a deck 37.3 m wide, accommodating 8 lanes of traffic initially (now been converted to a 10-lane bridge).

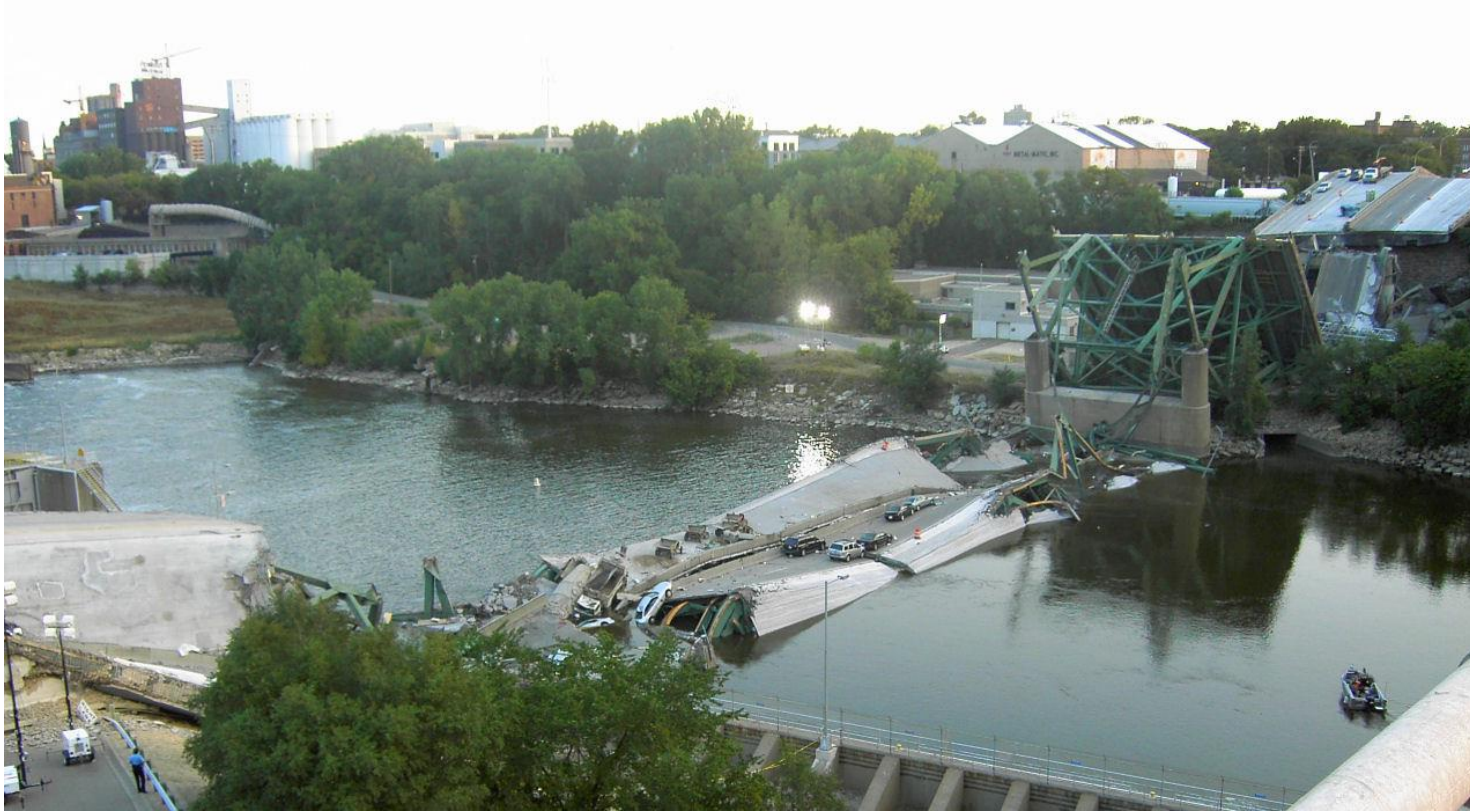
Minnesota Bridge, USA, 2007

- ❖ The trussed Arch Bridge across the Mississippi River collapsed In August 2007 in a busy hour, killing 13 persons and injuring about 150.
- ❖ Carrying 8-lane traffic, the bridge had been under scanner of special inspection since 1993.
- ❖ Opened In 1967, the bridge was first rated “Structurally Deficient” in 1990.

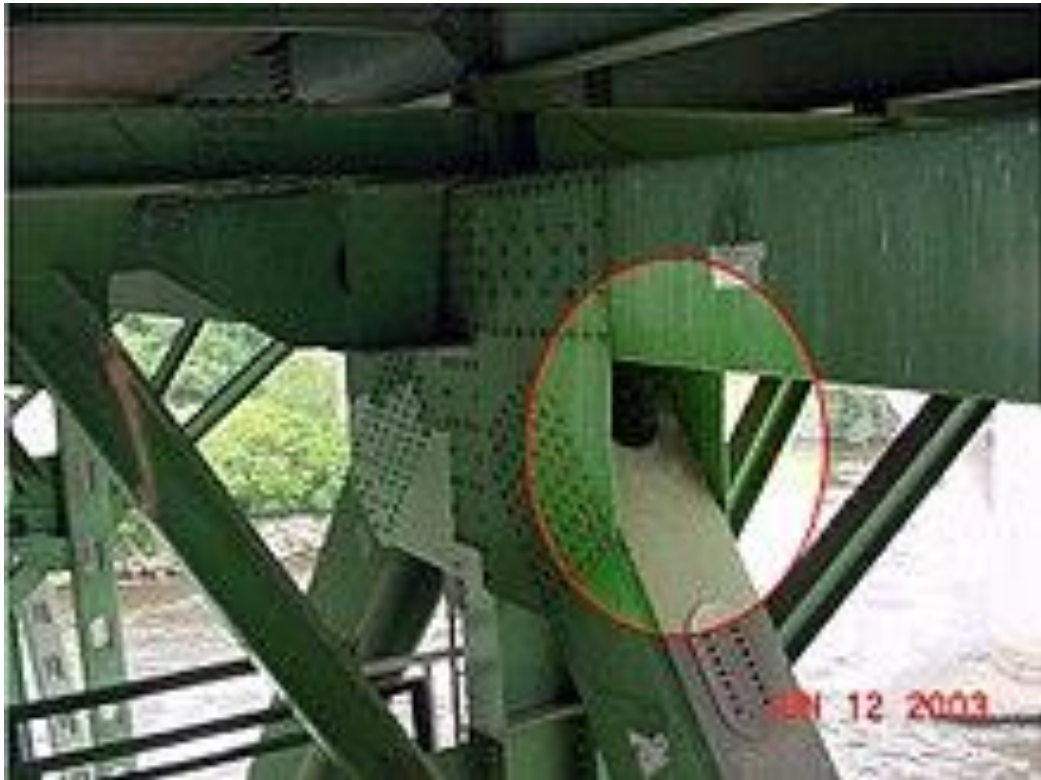
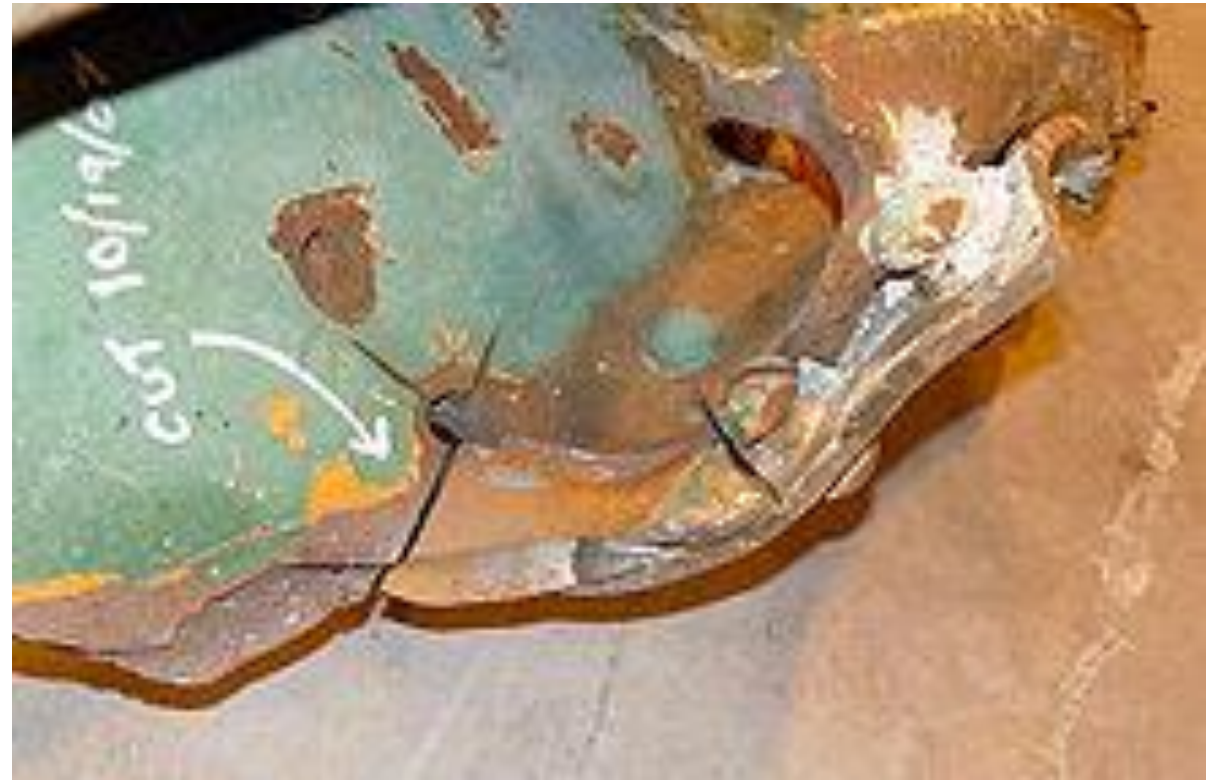
Minnesota Bridge, USA, 2007

❖ The reasons for failure as concluded by the investigation team were –

- ❑ Gusset thickness Inadequate.
- ❑ Overloading of Bridge due to uncontrolled overlay.
- ❑ Inadequate detailing at the end of cross girders.
