Workshop on “Design, Construction and Maintenance of Steel Bridges”

Forensic Investigation of Bowstring Girder during Construction

V N Heggade

19-20 October, 2024

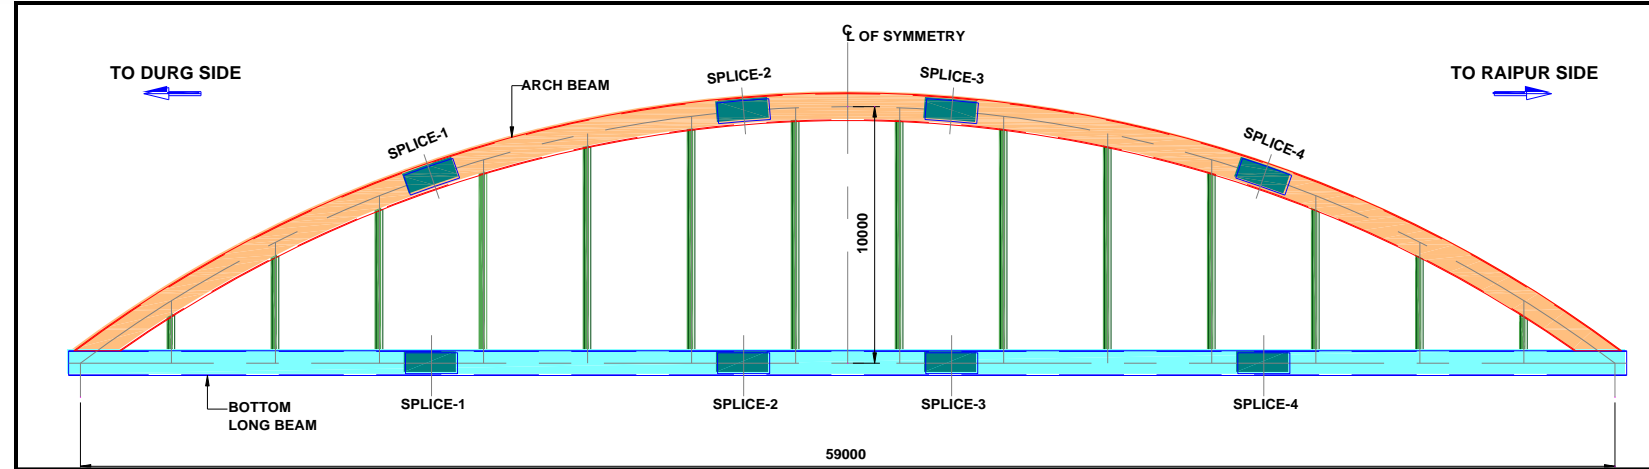
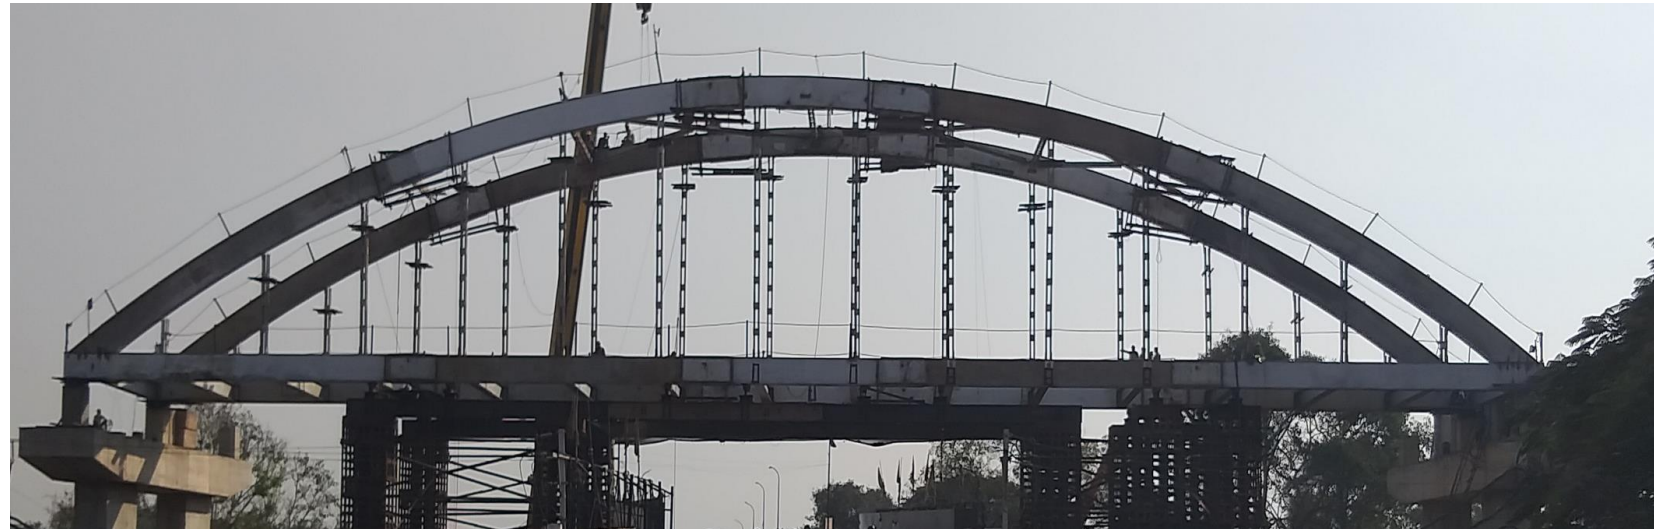
- During the erection, one of the arch ribs and bottom tie chord of RHS which is towards median side adjacent to already commissioned LHS arch bridge was found to be distorted beyond tolerance limits.
- On either side, the approaches were ready for commissioning. Only the deck slab was to be cast on floor beams.
- At the time of appointment of forensic expert, the distortion in the arch rib was corrected to certain extent but the acceptability of the same was in question.

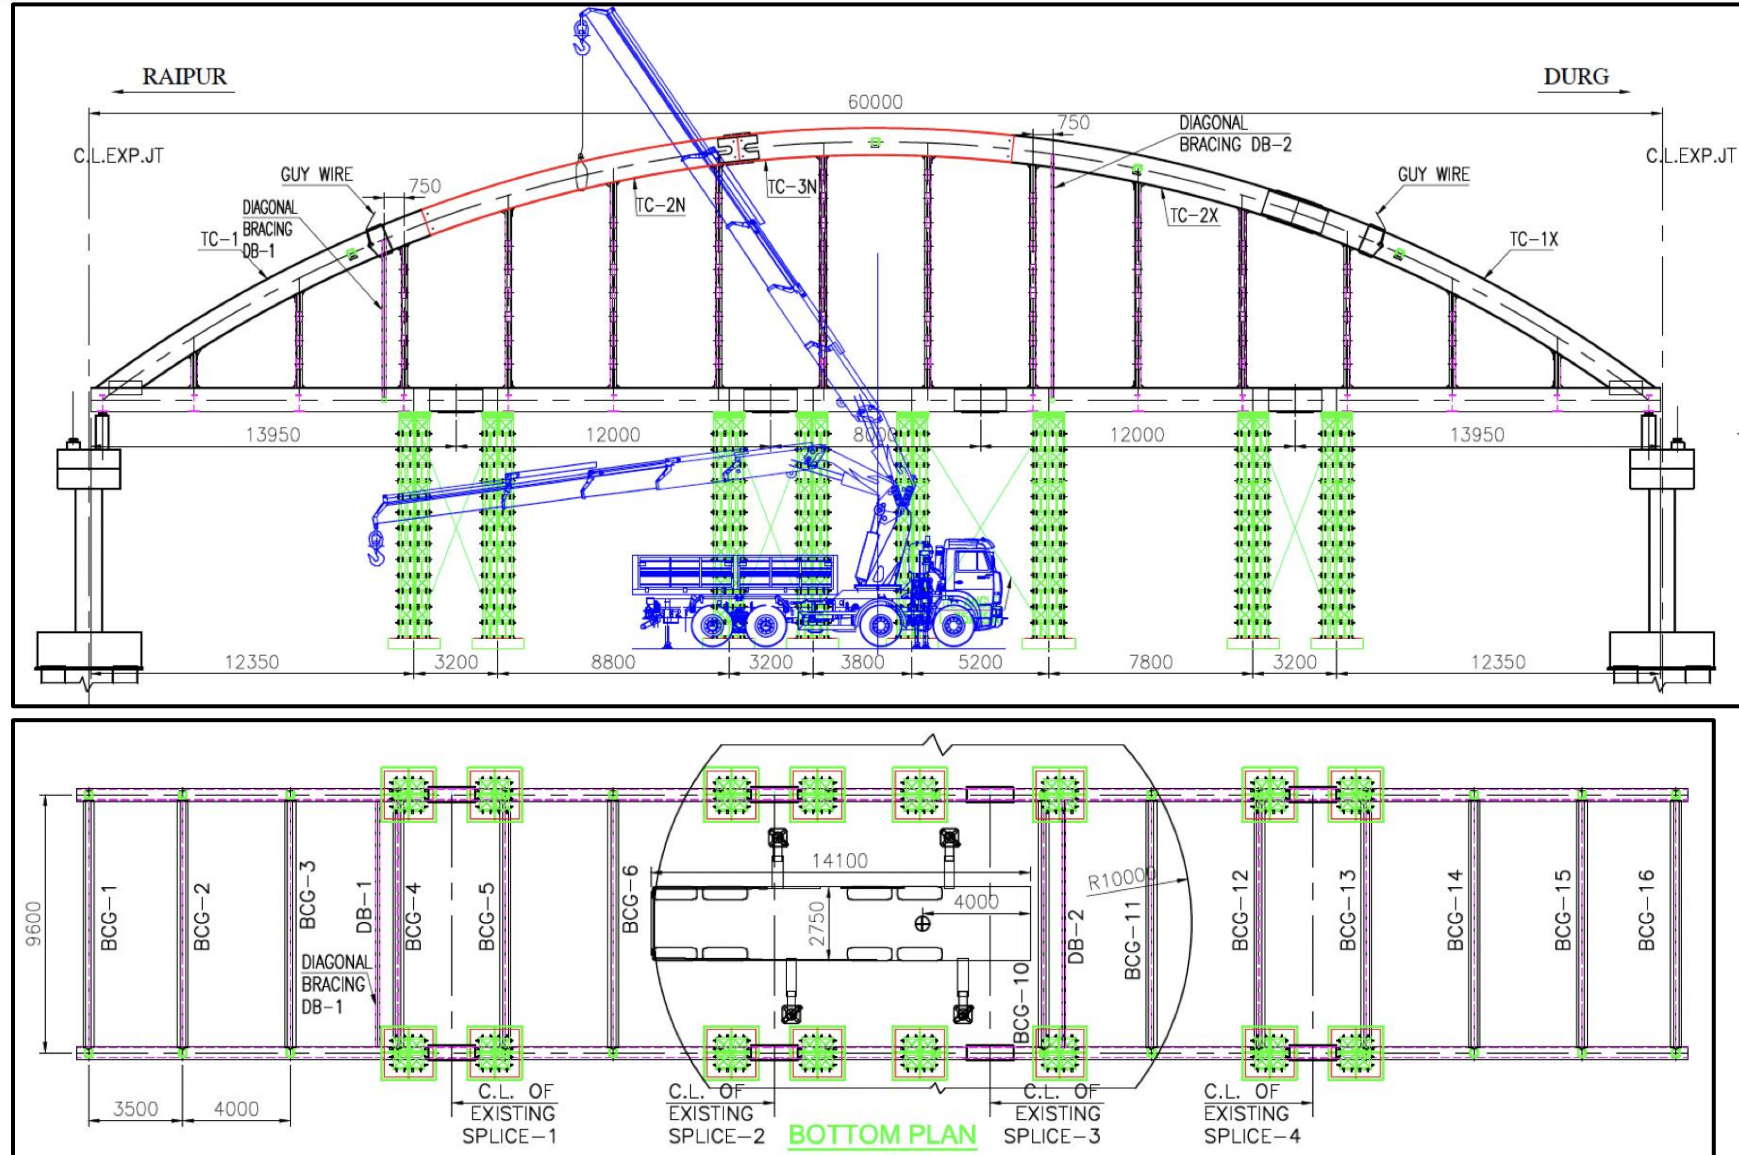
- Distortion in the alignment of one of the arch ribs and Bottom chord was detected during inspection.
- The distortion in the arch rib & the Tie chord were much beyond the permissible limits mentioned in IRC : Sp-104 and IRC : 24-2010.

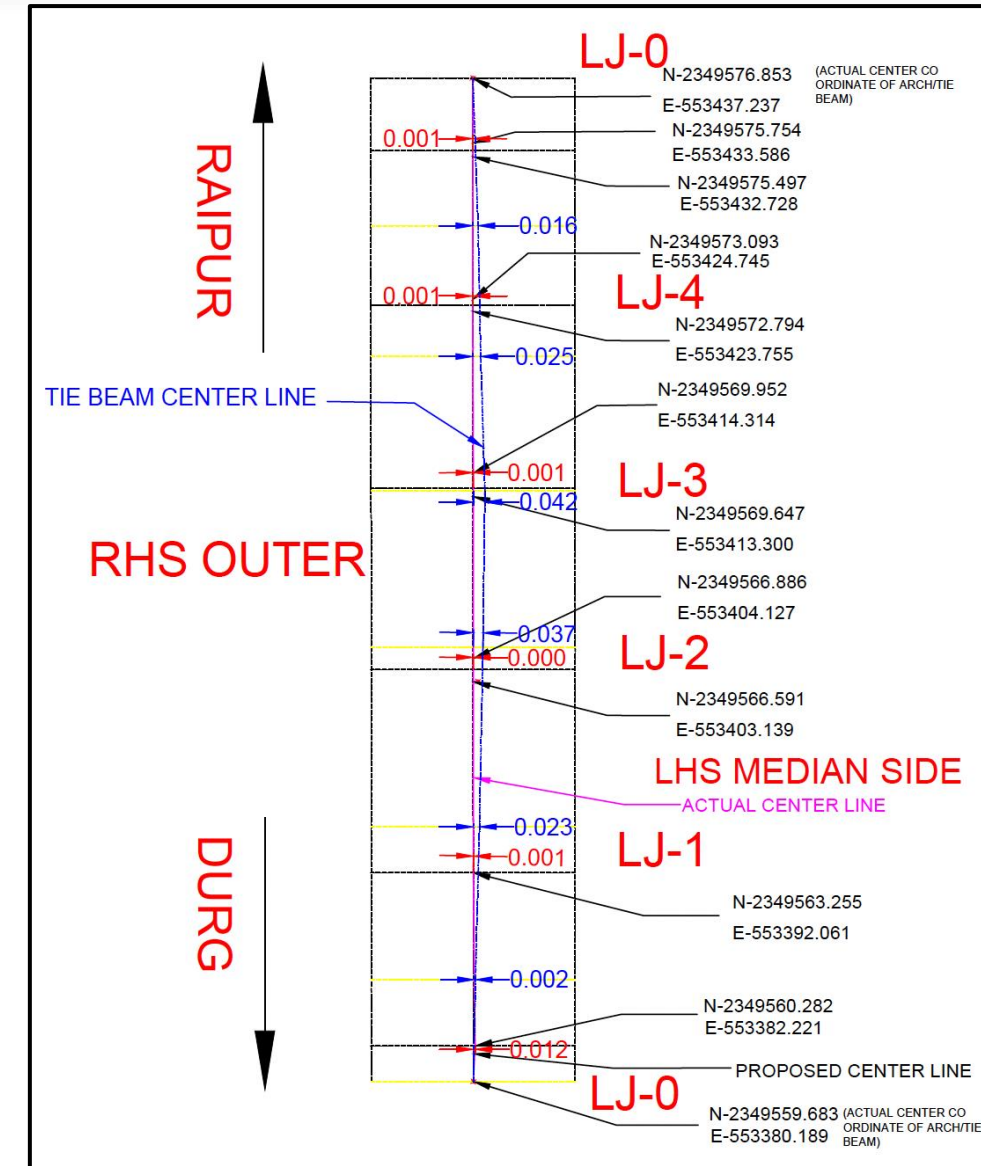
- After the rectification of the Arch ribs and Tie beam, the deviations from the designed positions at splice joint locations were around 10mm for the arch rib which was well within the tolerance limits of 15mm.
- However, for the Tie beam, the deviations at splice joints were varying from 23mm to 42mm which are beyond permissible tolerance limits, could not be rectified due to working space availability.
- In case of such non-conformities where the tolerance limits have exceeded in steel, excessive bulging takes place in concrete, etc. non-linear analysis for design verifications is normally adopted.
- However, linear elastic 3D analysis is carried out in this case to verify for the design adequacy.

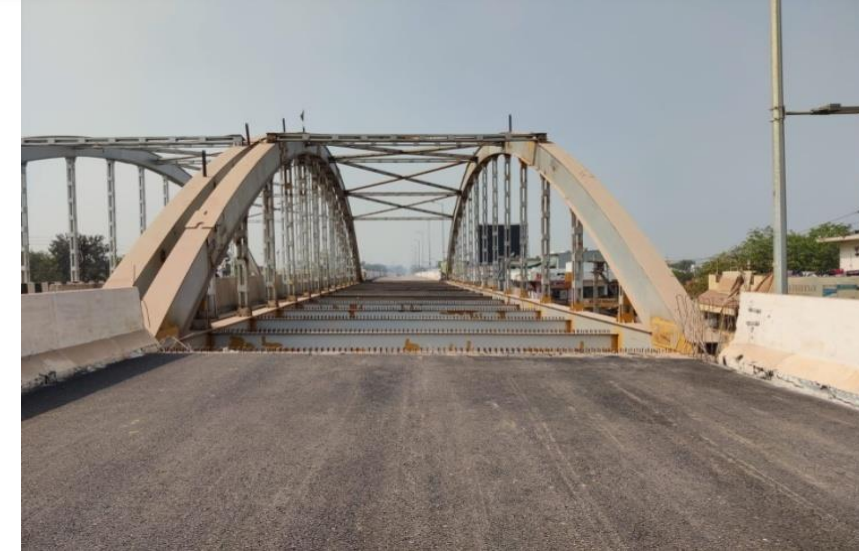
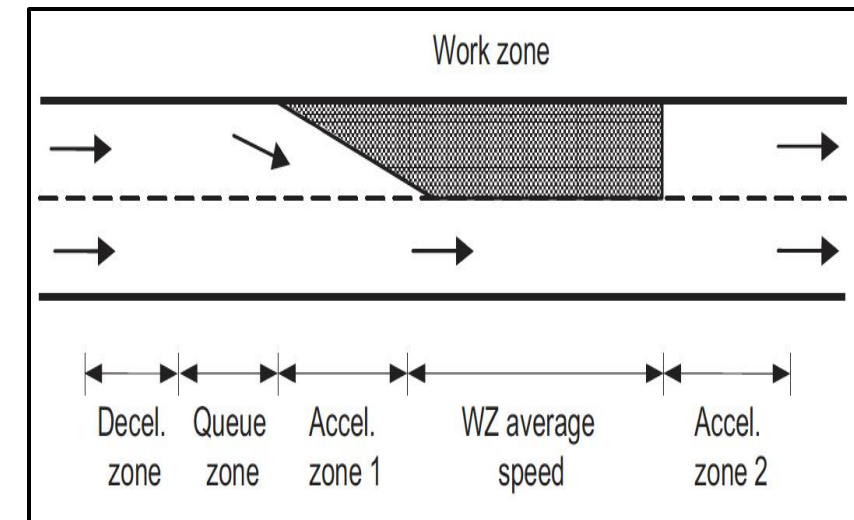
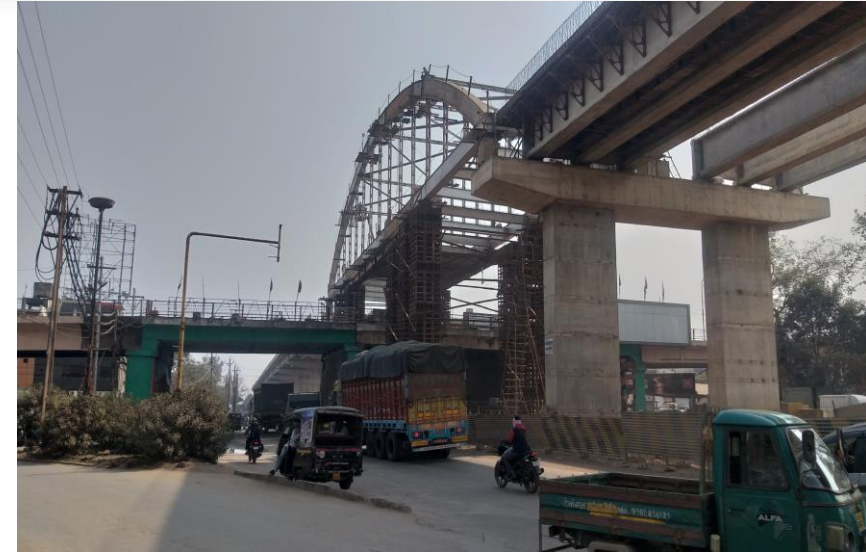
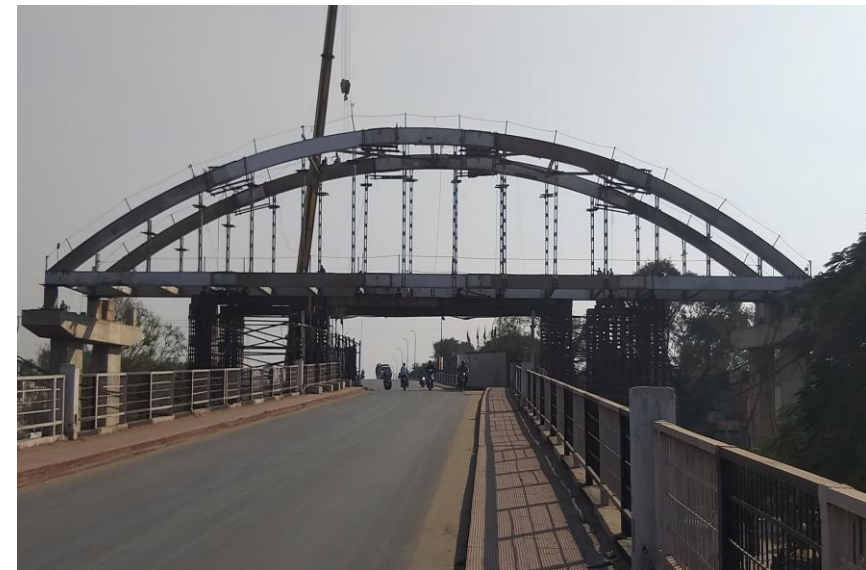
- On the basis of the 2 D analysis, already another 3 bowstring girder bridges in the same package were fabricated and erected including the one on LHS which is commissioned for traffic.
- It is found that if the 3D analysis was done in the original design, the utilization ratio would have been higher than 0.95.
- In view of this, if strengthening of the bottom chord is recommended, on the assumption that utilisation ratio is very high, the same has to be carried out for other 3 flyovers which are already fabricated and erected.

- In a situation like this where the design and construction is not in accordance with the sections of the standard, IRC :24 recommends load testing.
- In this case, the design shows that the structure is safe despite crossing the tolerance limits of 15mm in bottom chord.
- The decision also had to be made keeping in view the ramification on other 3 flyovers which are already in position and impact on sustainability.
- However, as a measure of abundant precaution after completion of the bridge, the load testing as per IRC code was recommended.
